Mine Scarred Lands to Open Space

(Restoring Vital Public Resources from “Holey Crap”)

Jason Lederer: Senior Resource Specialist
Summit County Open Space and Trails

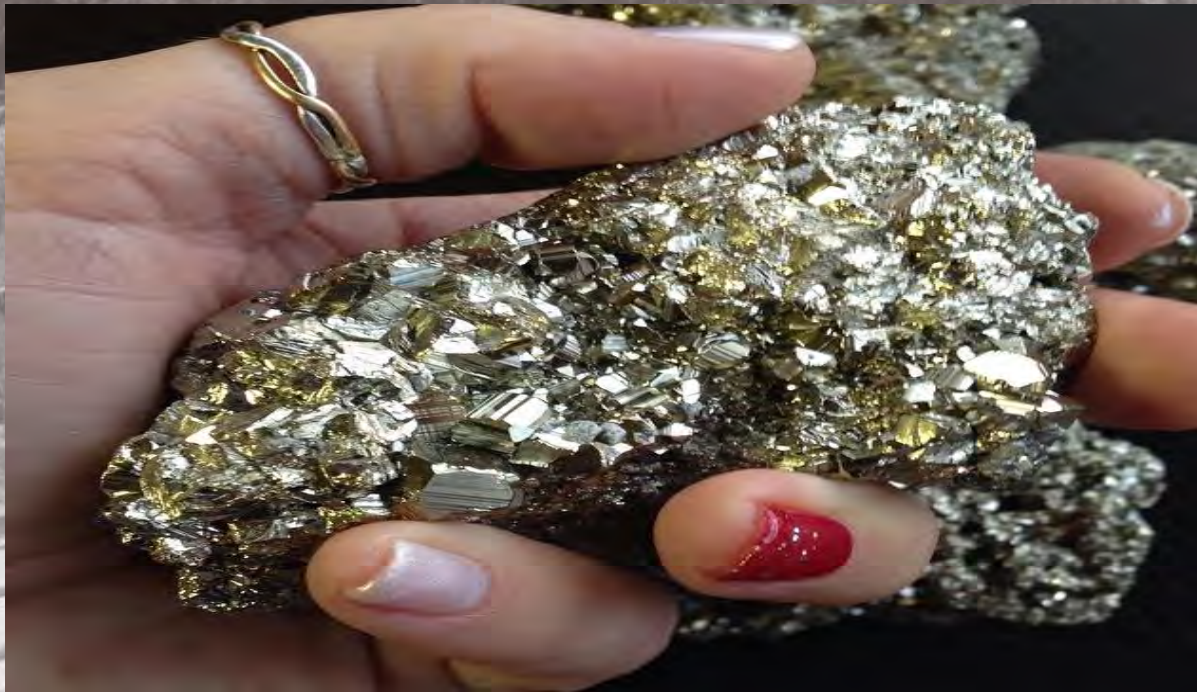
Iron Pyrite (Fools Gold) is oxidized when exposed to air and water

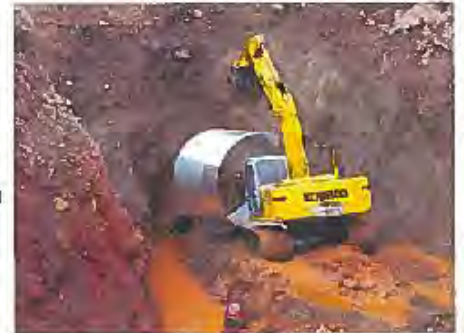
Figure #3: Installation of large diameter culvert at Level F following portal excavation.

In 2012 a portal rehab project was undertaken that involved excavation of the collapsed portals at both Level C and F, followed by installation of large diameter culvert to provide safe access. Once safe access was establish, initial underground investigations were conducted on both levels to better inform next steps and remedial options.

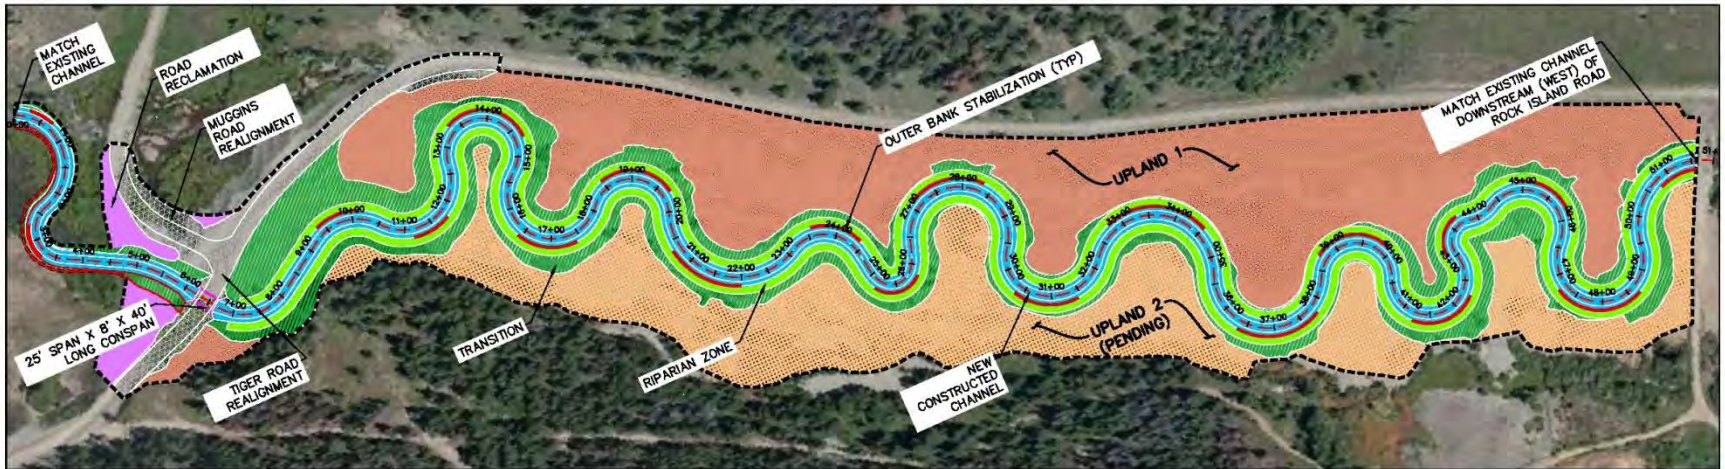
① RIVER REALIGNMENT PLANVIEW

TITLE
OVERALL RIVER PLAN AND PROFILE

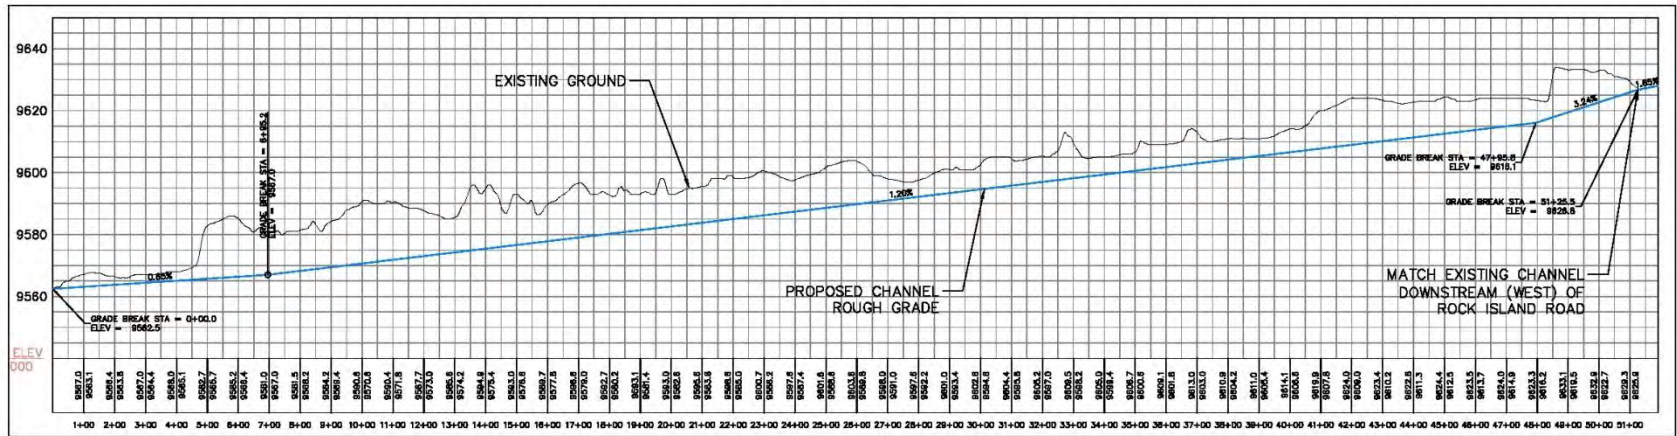
② RIVER REALIGNMENT STRAIGHT PROFILE

1001 HORIZONTAL TO VERTICAL SCALE

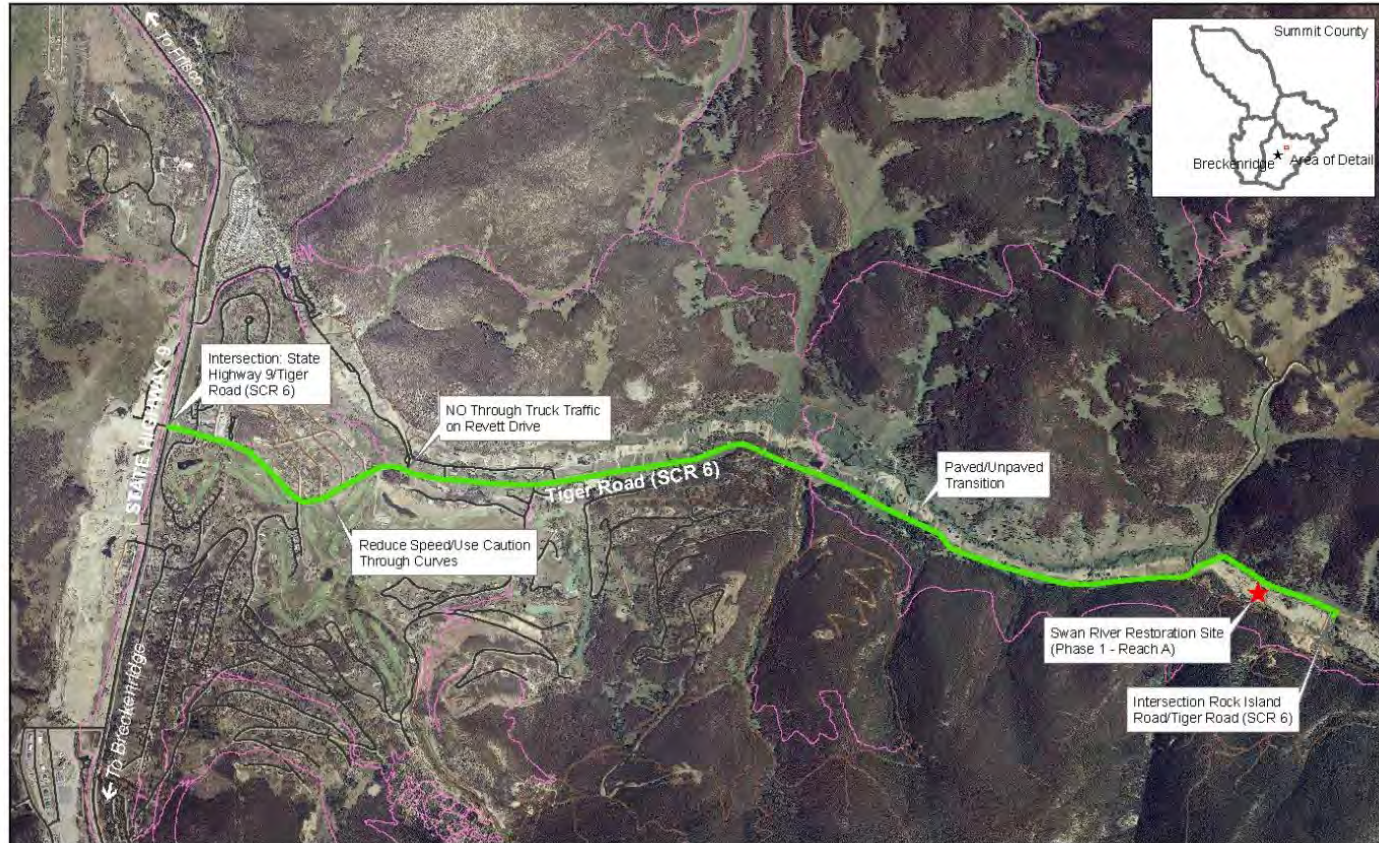
Truck Haul Route Plan

This predefined truck haul route for truck traffic associated with the Swan River Restoration Project (Phase 1 - Reach A) and associated Construction Phase Traffic Control Plan is developed to help mitigate the effects of truck traffic on residents and recreationalists along and adjacent to the Tiger Road (SCR 6) haul route. This plan is specific to Phase 1 (Reach A) of the project only.

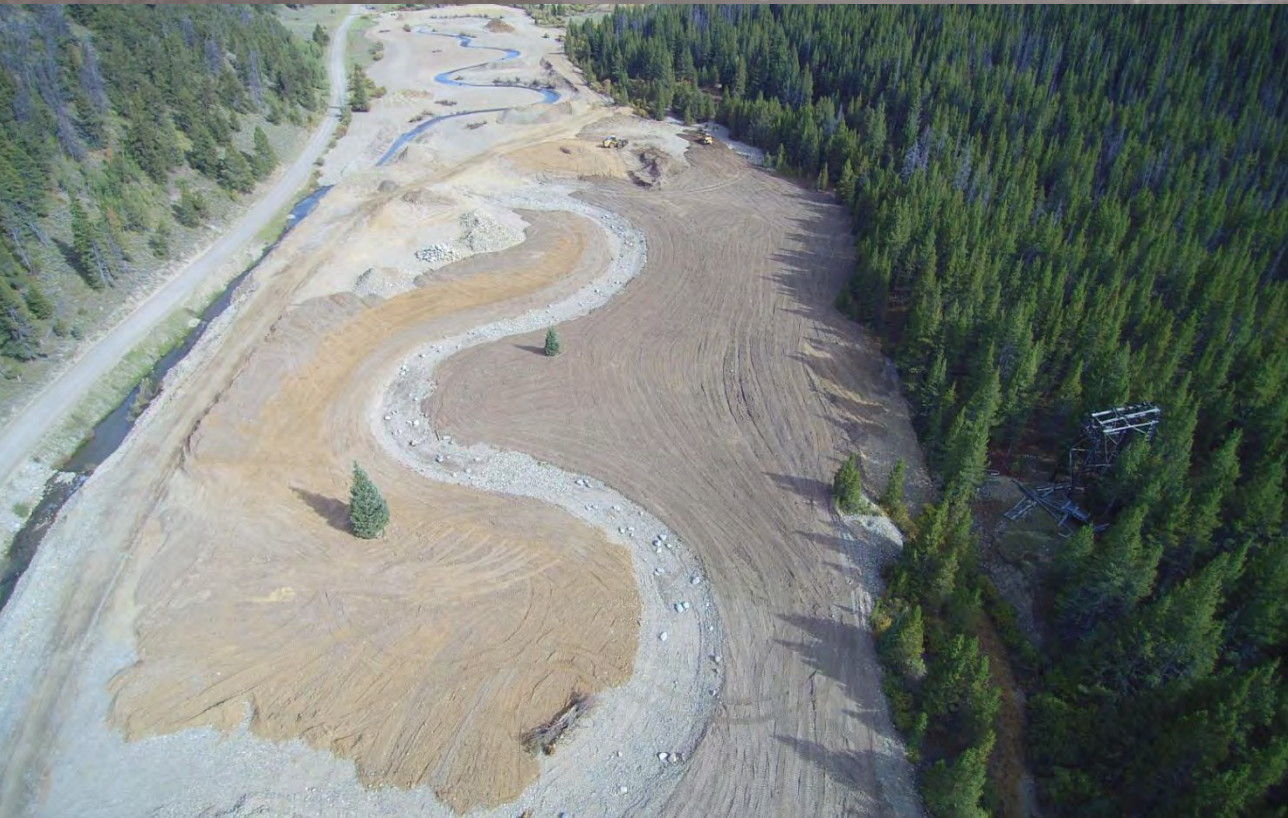
Unanticipated mine wastes in stream alignment

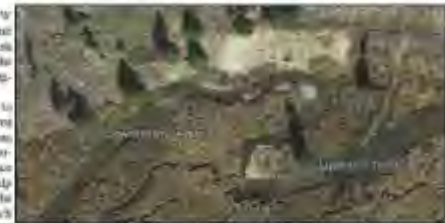
Location of Swan River survey reach.

The reach that we surveyed was 404 feet in length and averaged 15.8 feet in stream width. This was a five-flooding section bounded on both ends by beaver pond complexes. The upstream section of the reach was a beaver dam. We used two backpack electrofishers to conduct a two-pass depletion estimate of the total fish population within that reach. All fish were anesthetized. A subset of the fish were weighed, and all fish were returned to the water immediately upon completion of data collection.

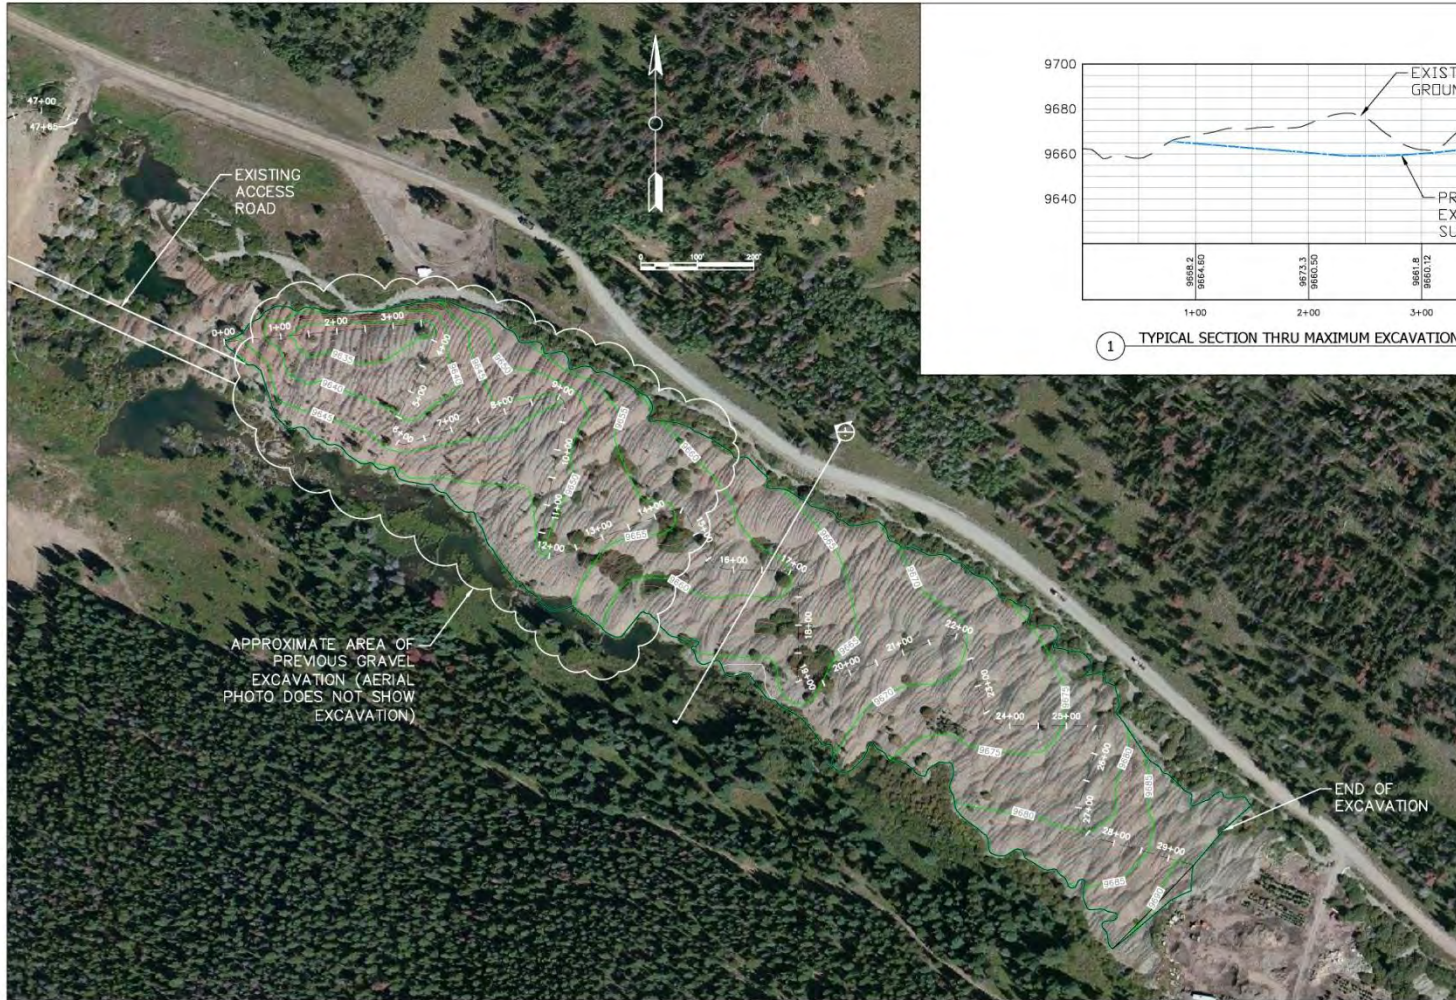
SHEET NO
1A

1 TYPICAL SECTION THRU MAXIMUM EXCAVATION CONFIGURATION

EXCAVATION =
195,000 CY

TITLE
PHASE 2 - MASS EXCAVATION
MAXIMUM CUT CONFIGURATION
WITH AERIAL PHOTO
