# There goes the neighborhood! Water quality challenges in a changing environment

Jessica Doran, EcoMetrics  
Anne Murphy, Town of Breckenridge

# Cucumber Gulch Preserve

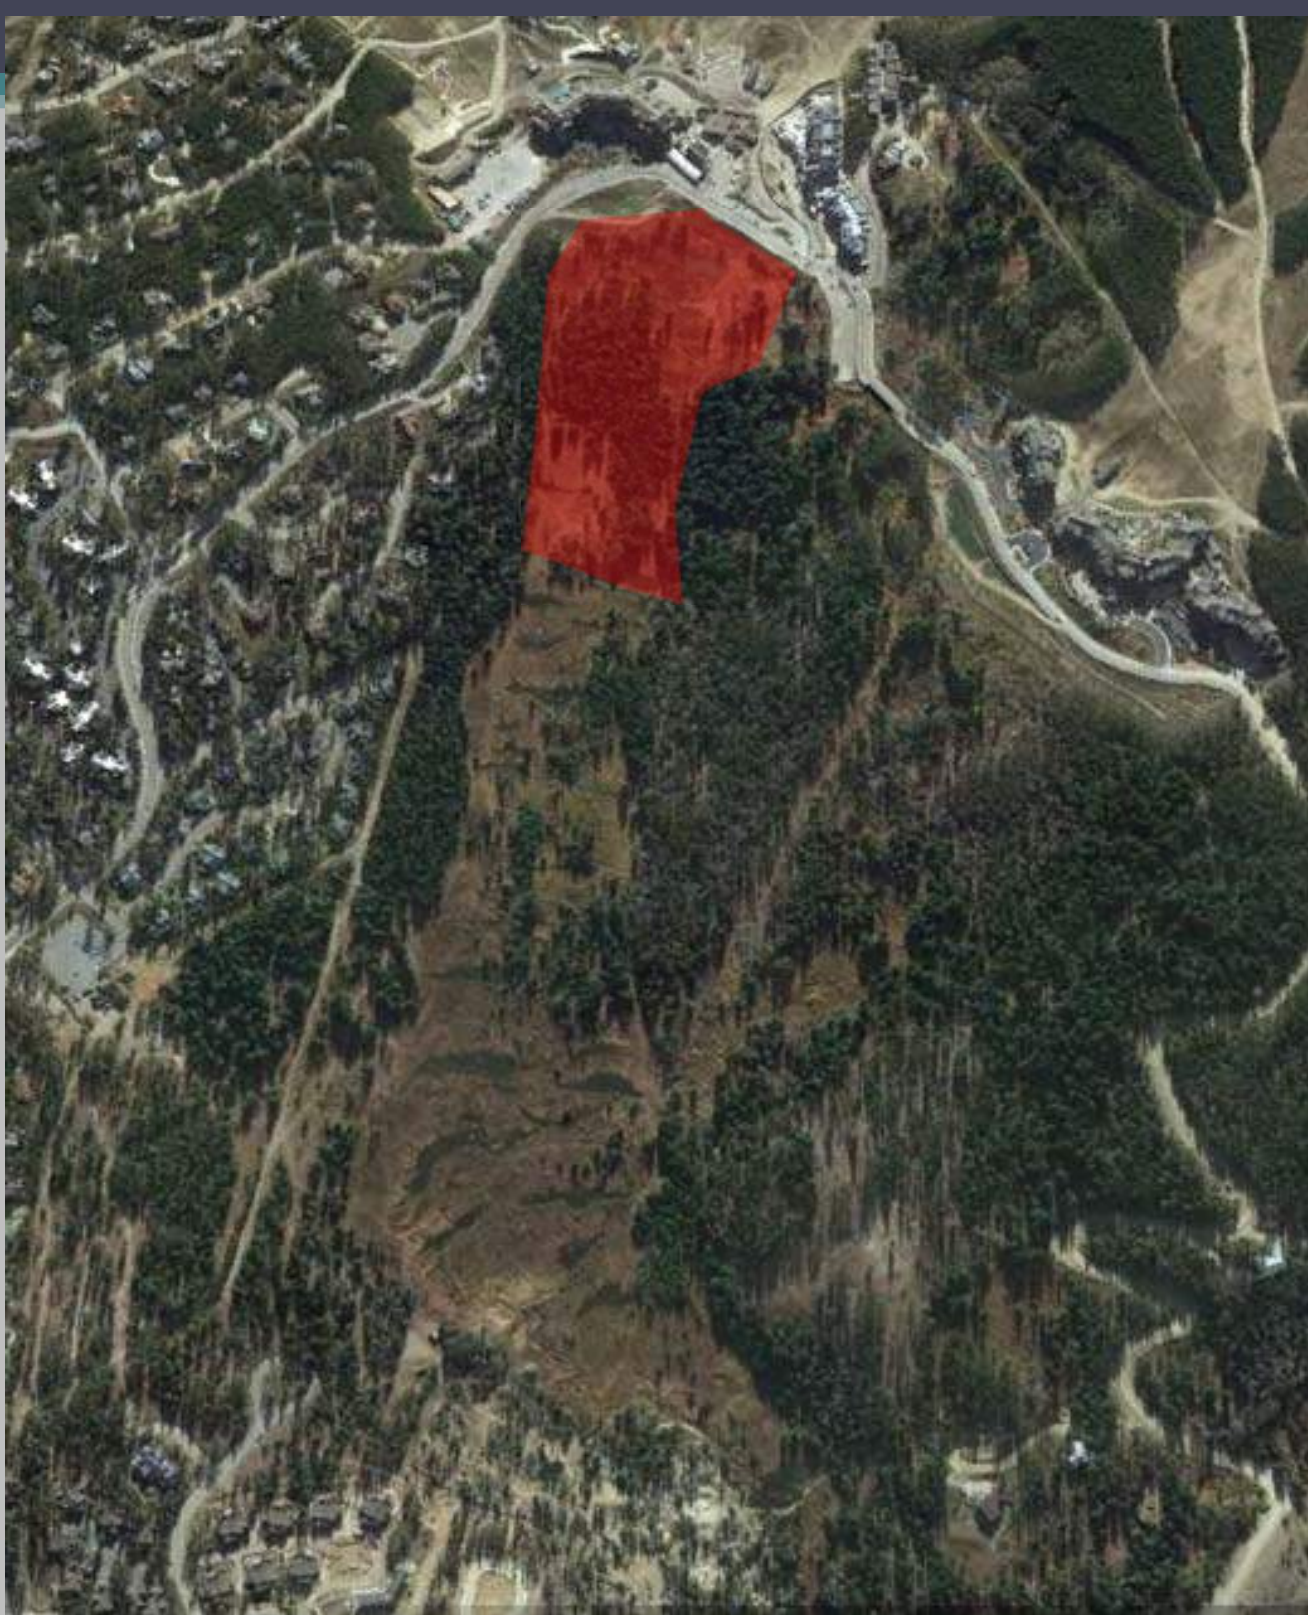
9/23/2011

60" culvert outlet

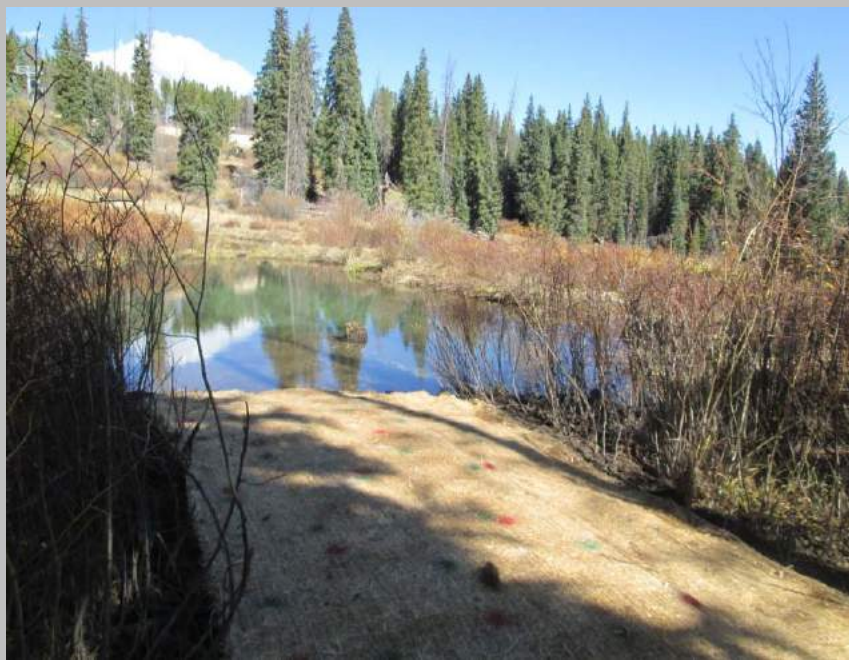
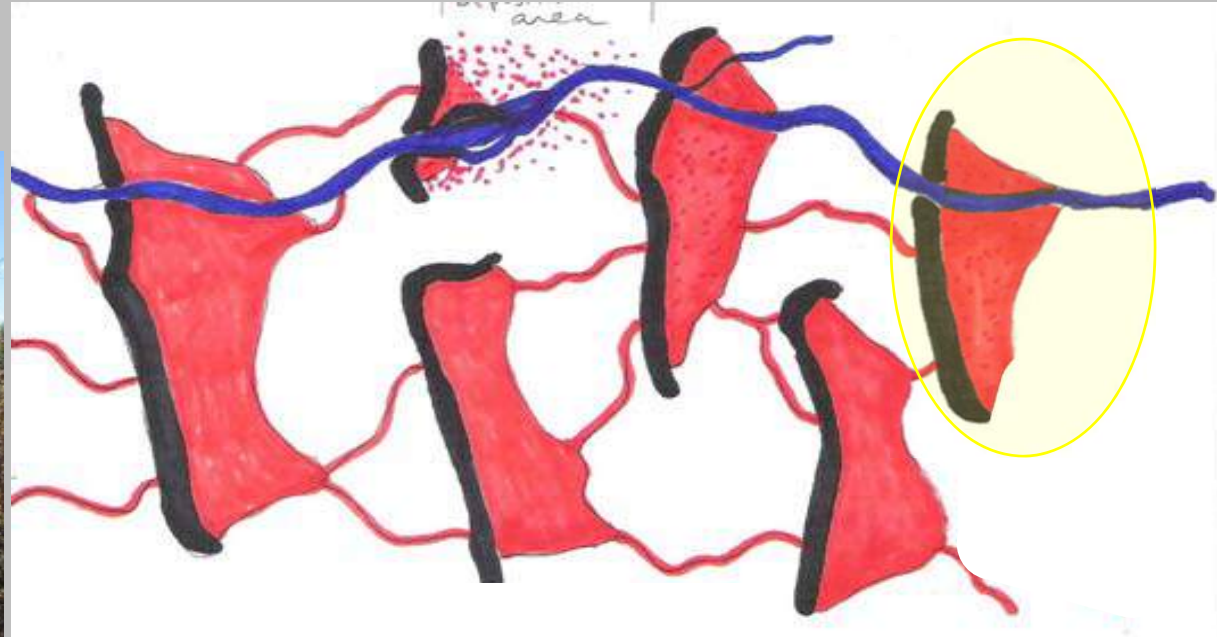
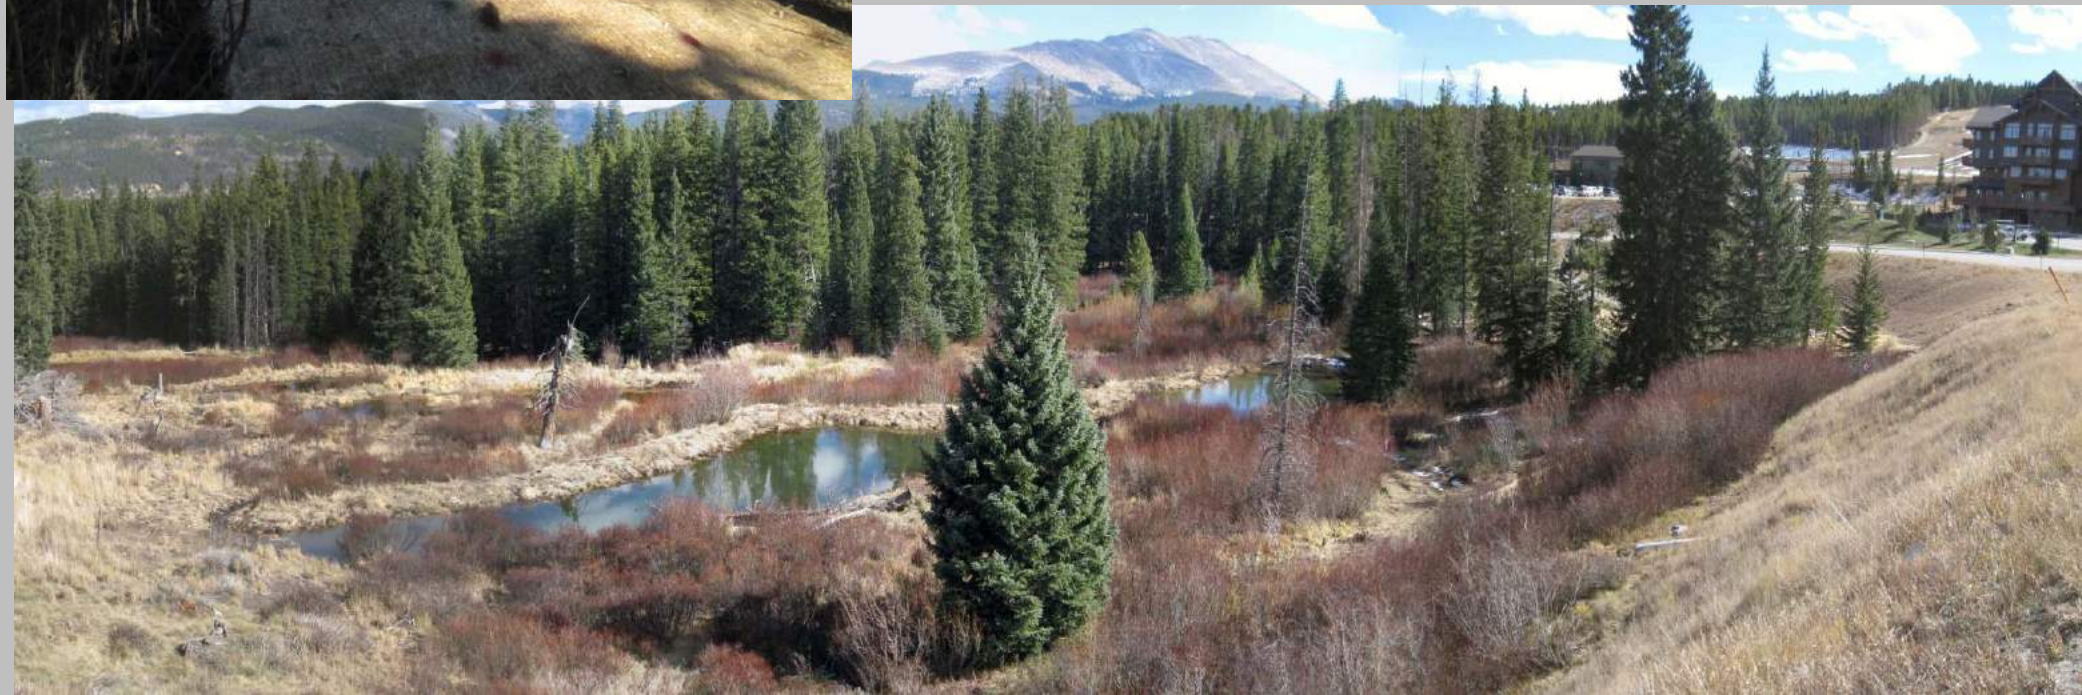
## “Spreader pond”

# Treatment

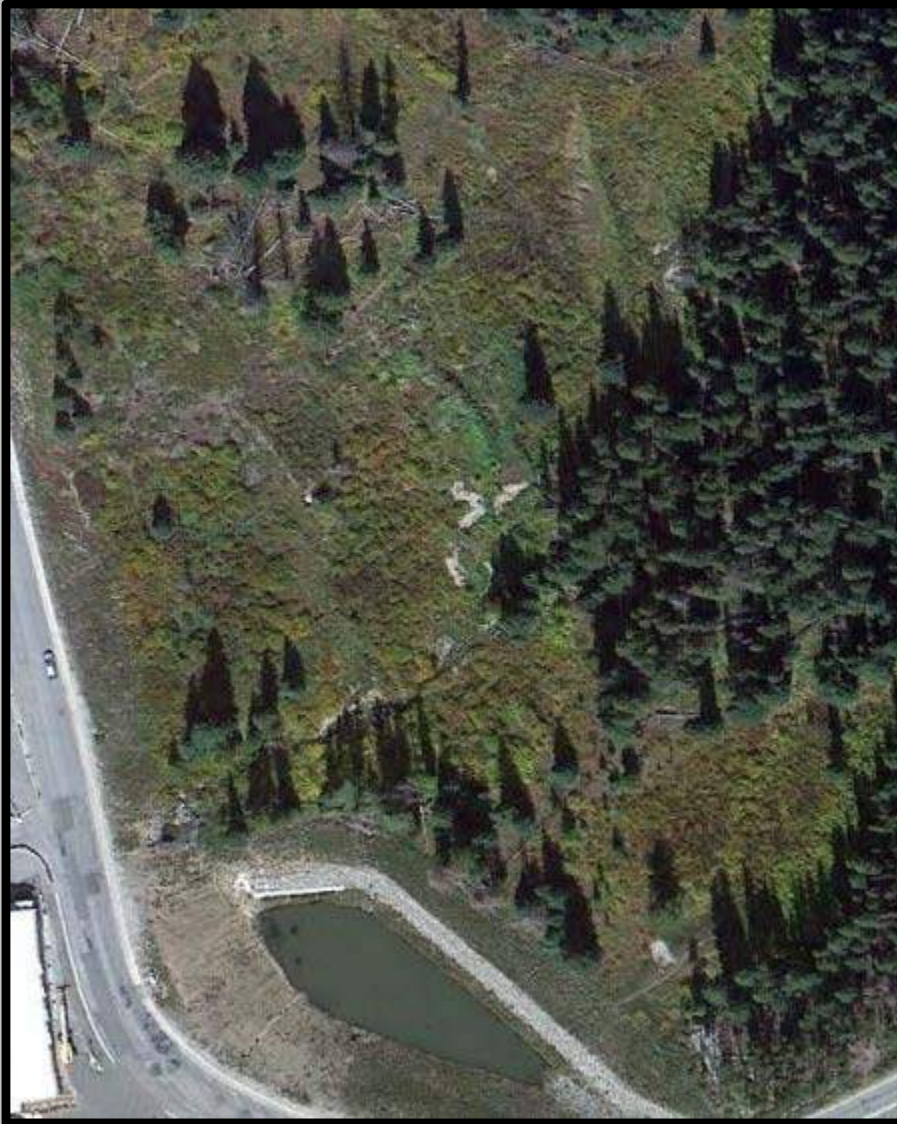
Study site locations and the wetland delineations from 1997 and 2011. The wetland area decrease from 1997 to 2011 and results from the study sites in 2012 show that much of the 2011 delineated wetland did not actually meet jurisdictional standards due to lack of hydrology.

Wetland status in 2016. The only non-wetland sites are J and N on the perimeter. Study sites E and F have been wavering between wetland and non-wetland based on the hydrology from year to year.

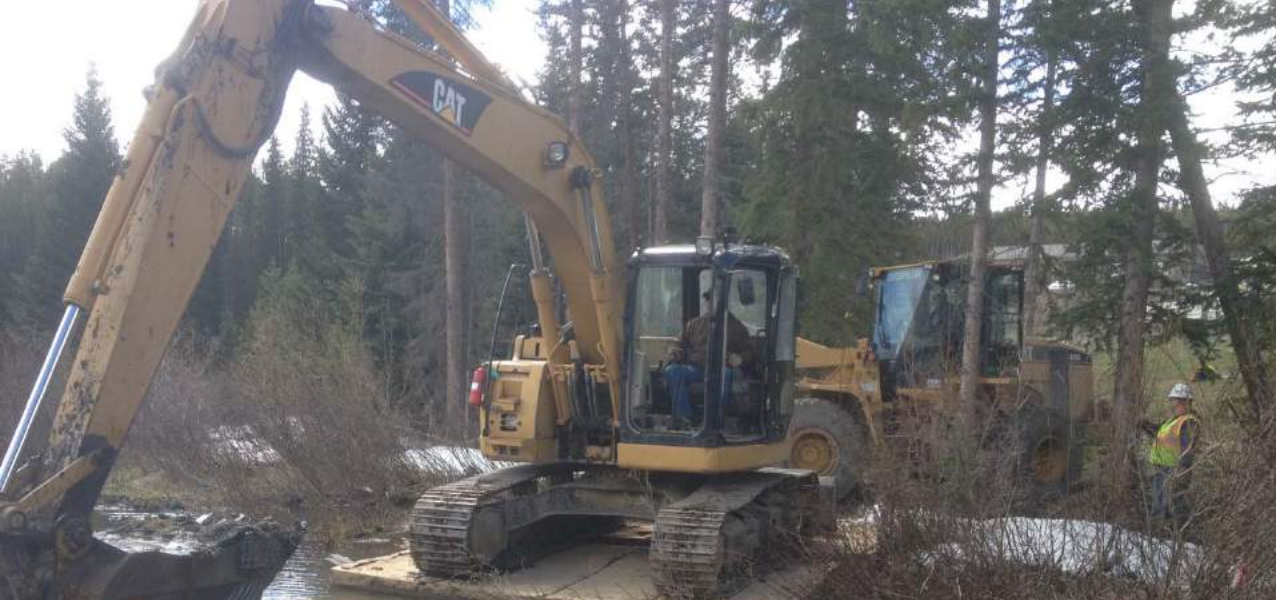
**CGP Spreader Pond - Cross Section 2**

<b>Year</b>	<b>Amount of sediment</b>
<b>2013</b>	17.2 cubic yards
<b>2014</b>	31.6 cubic yards
<b>2015</b>	19.6 cubic yards

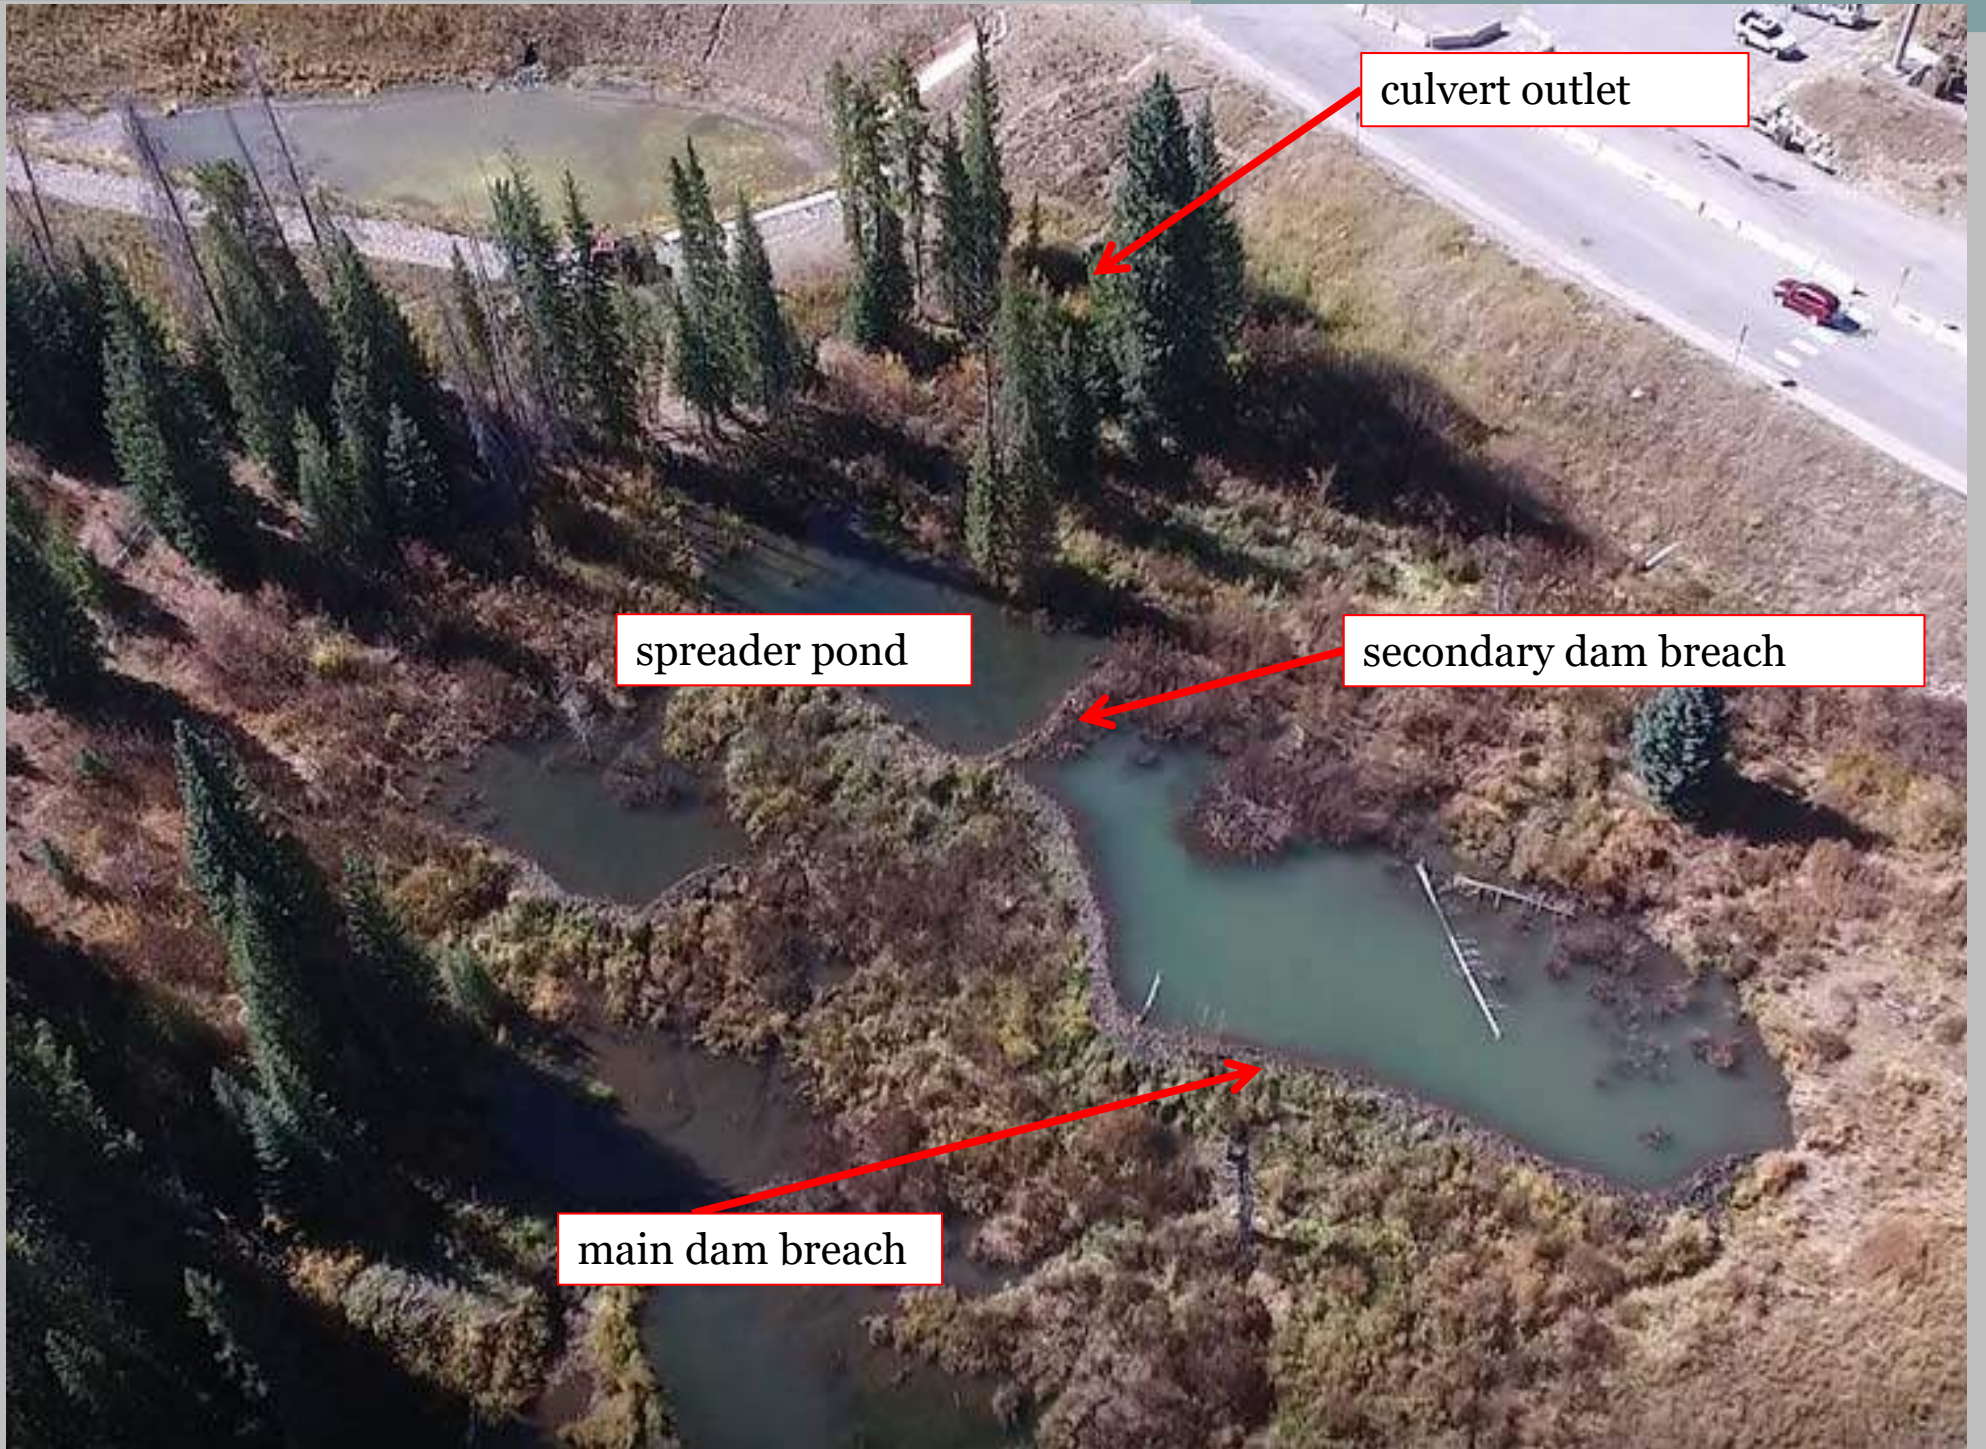
culvert outlet

spreader pond

secondary dam breach

main dam breach

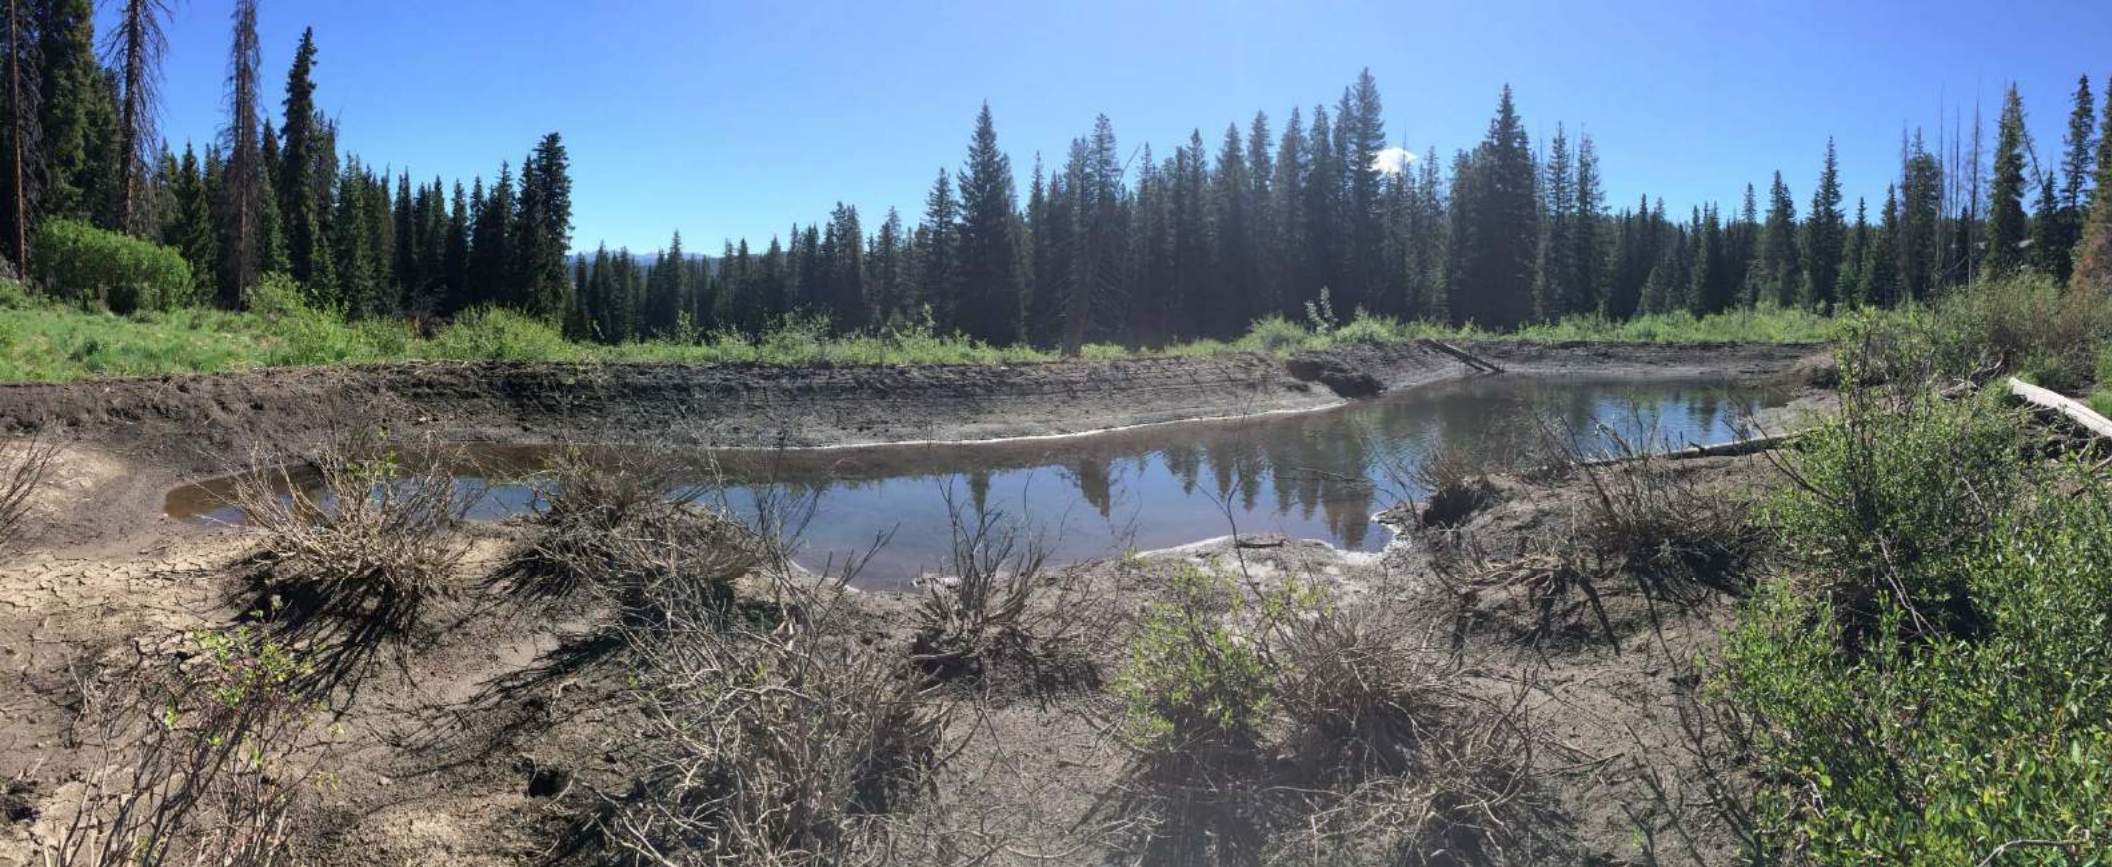
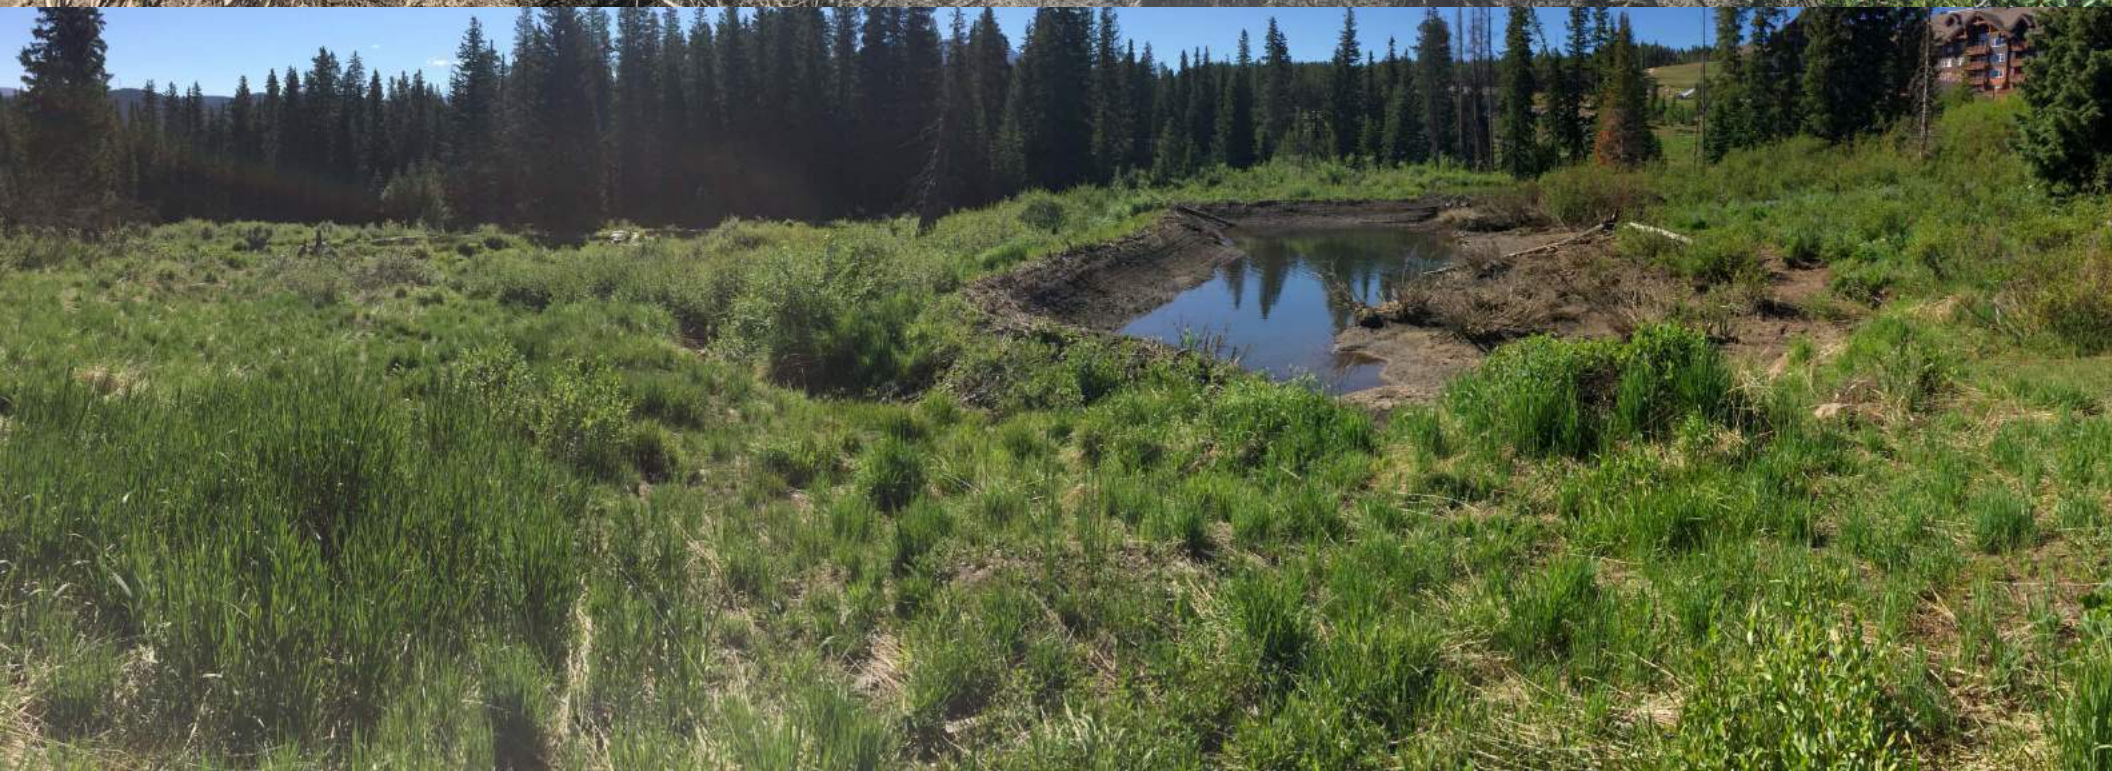
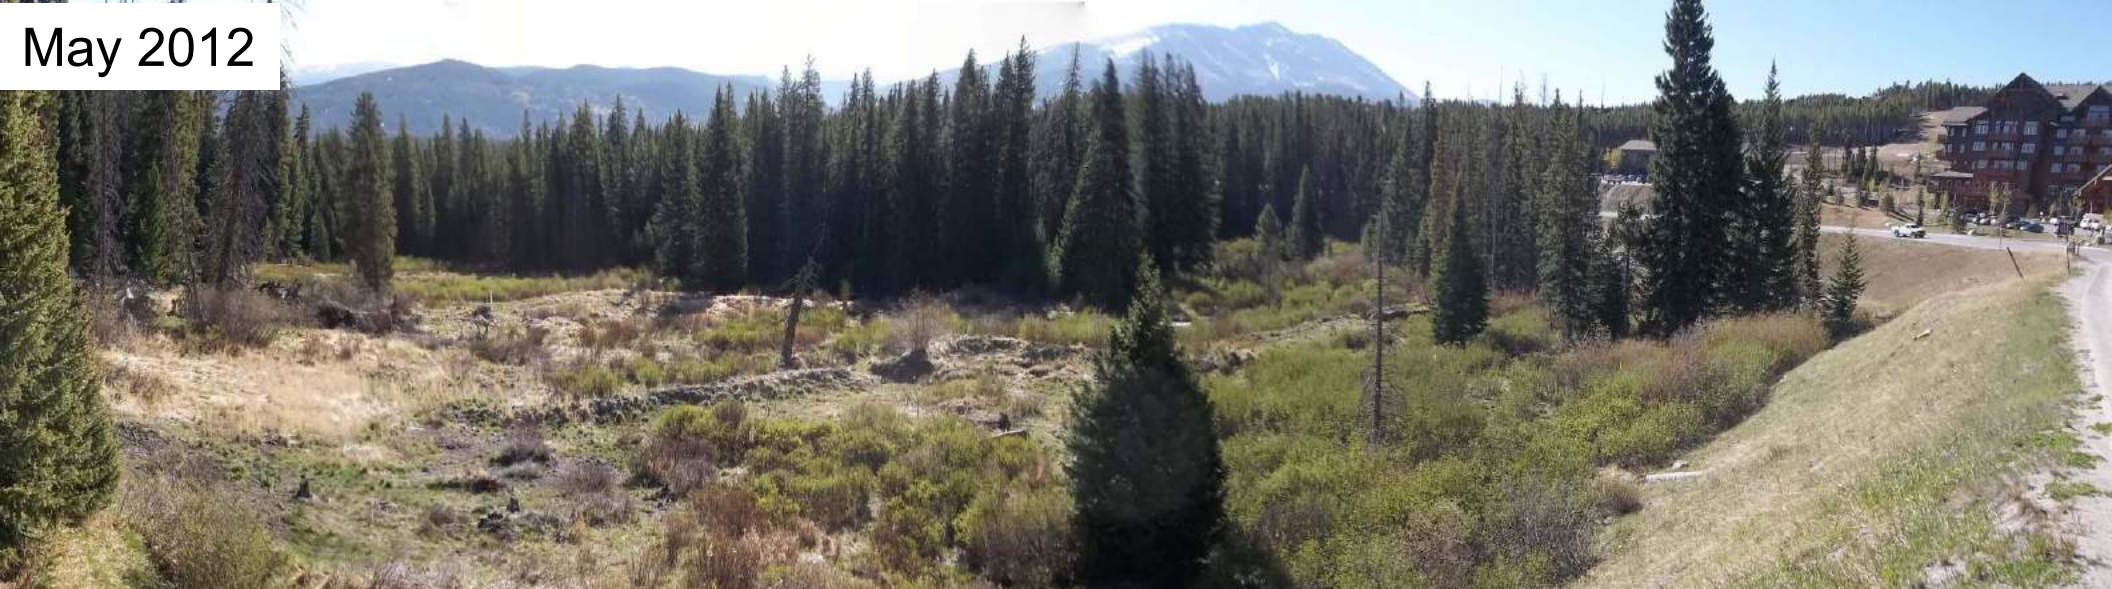
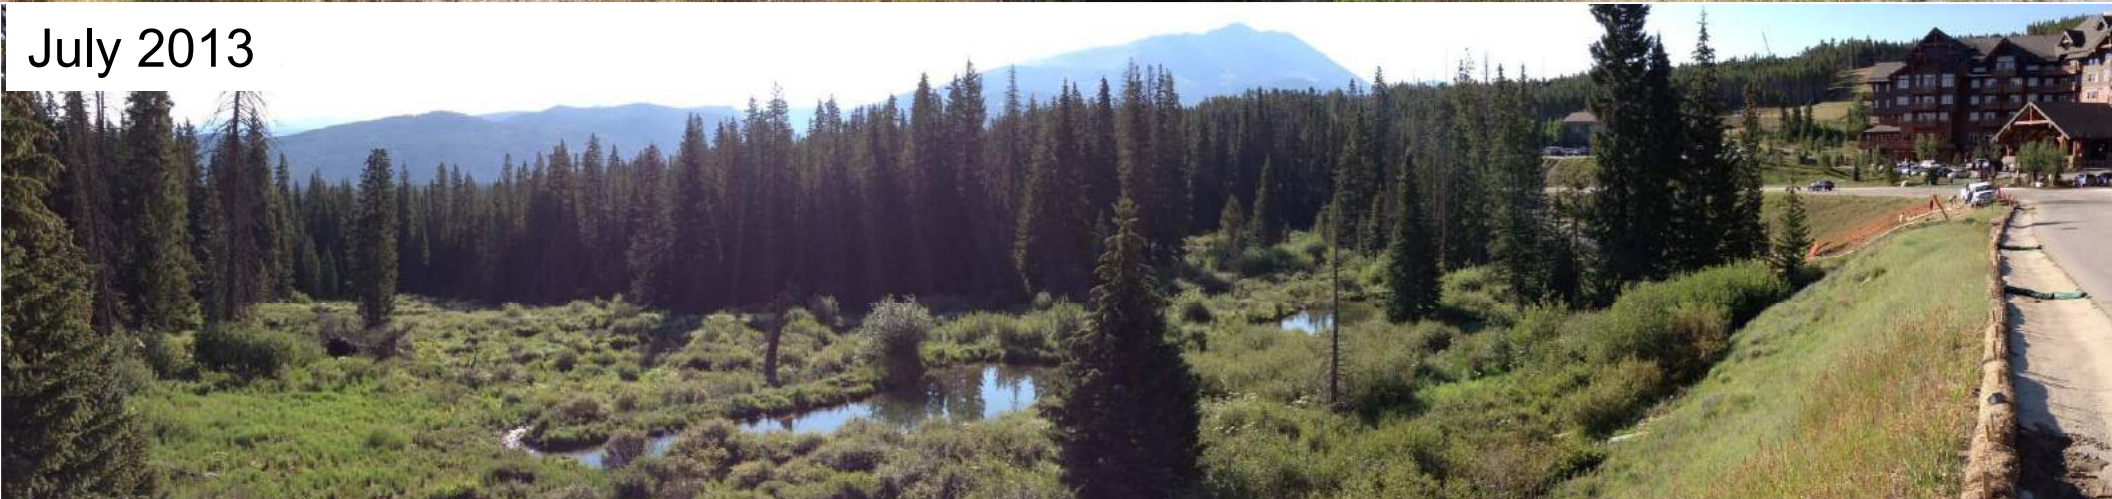
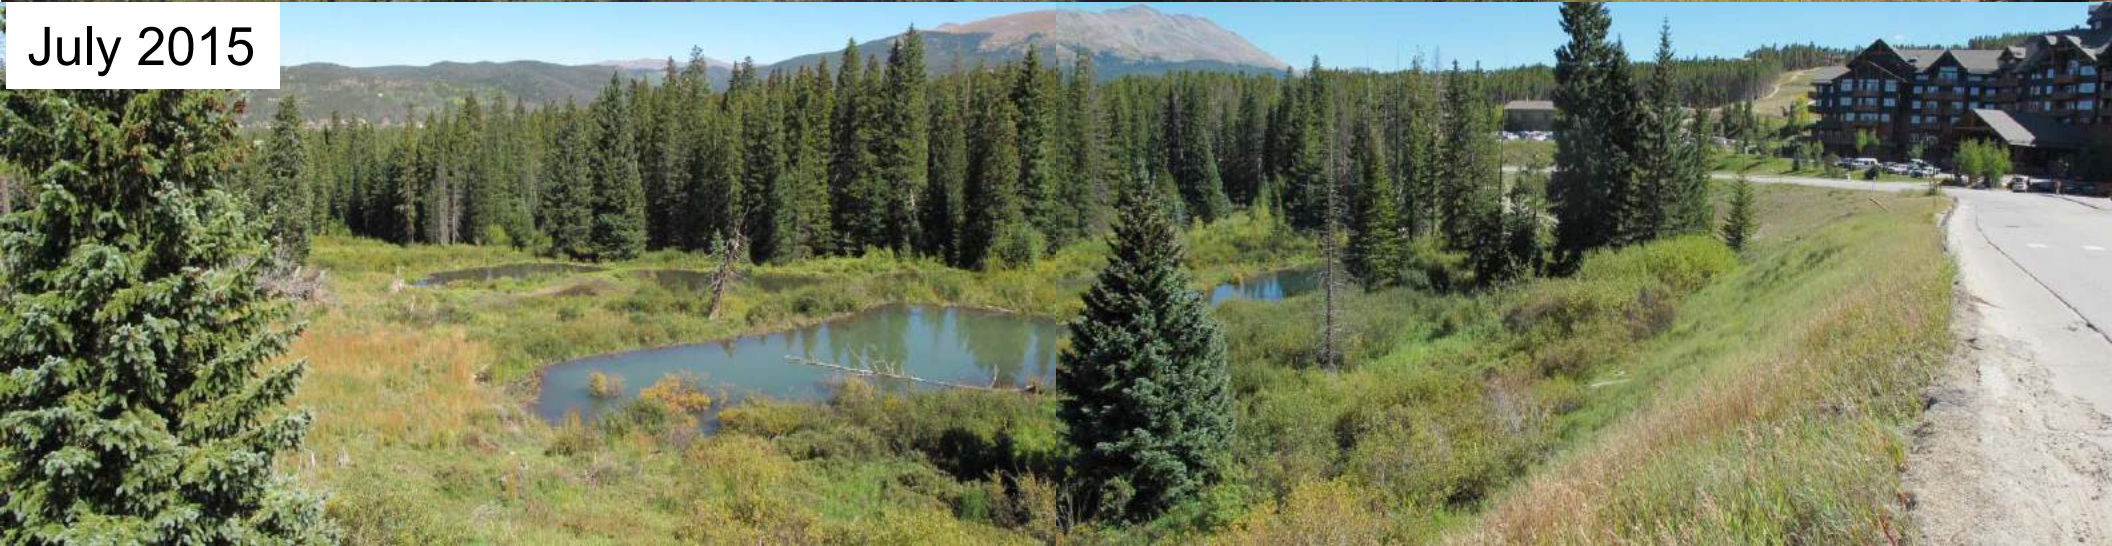
May 2012

July 2013

July 2015

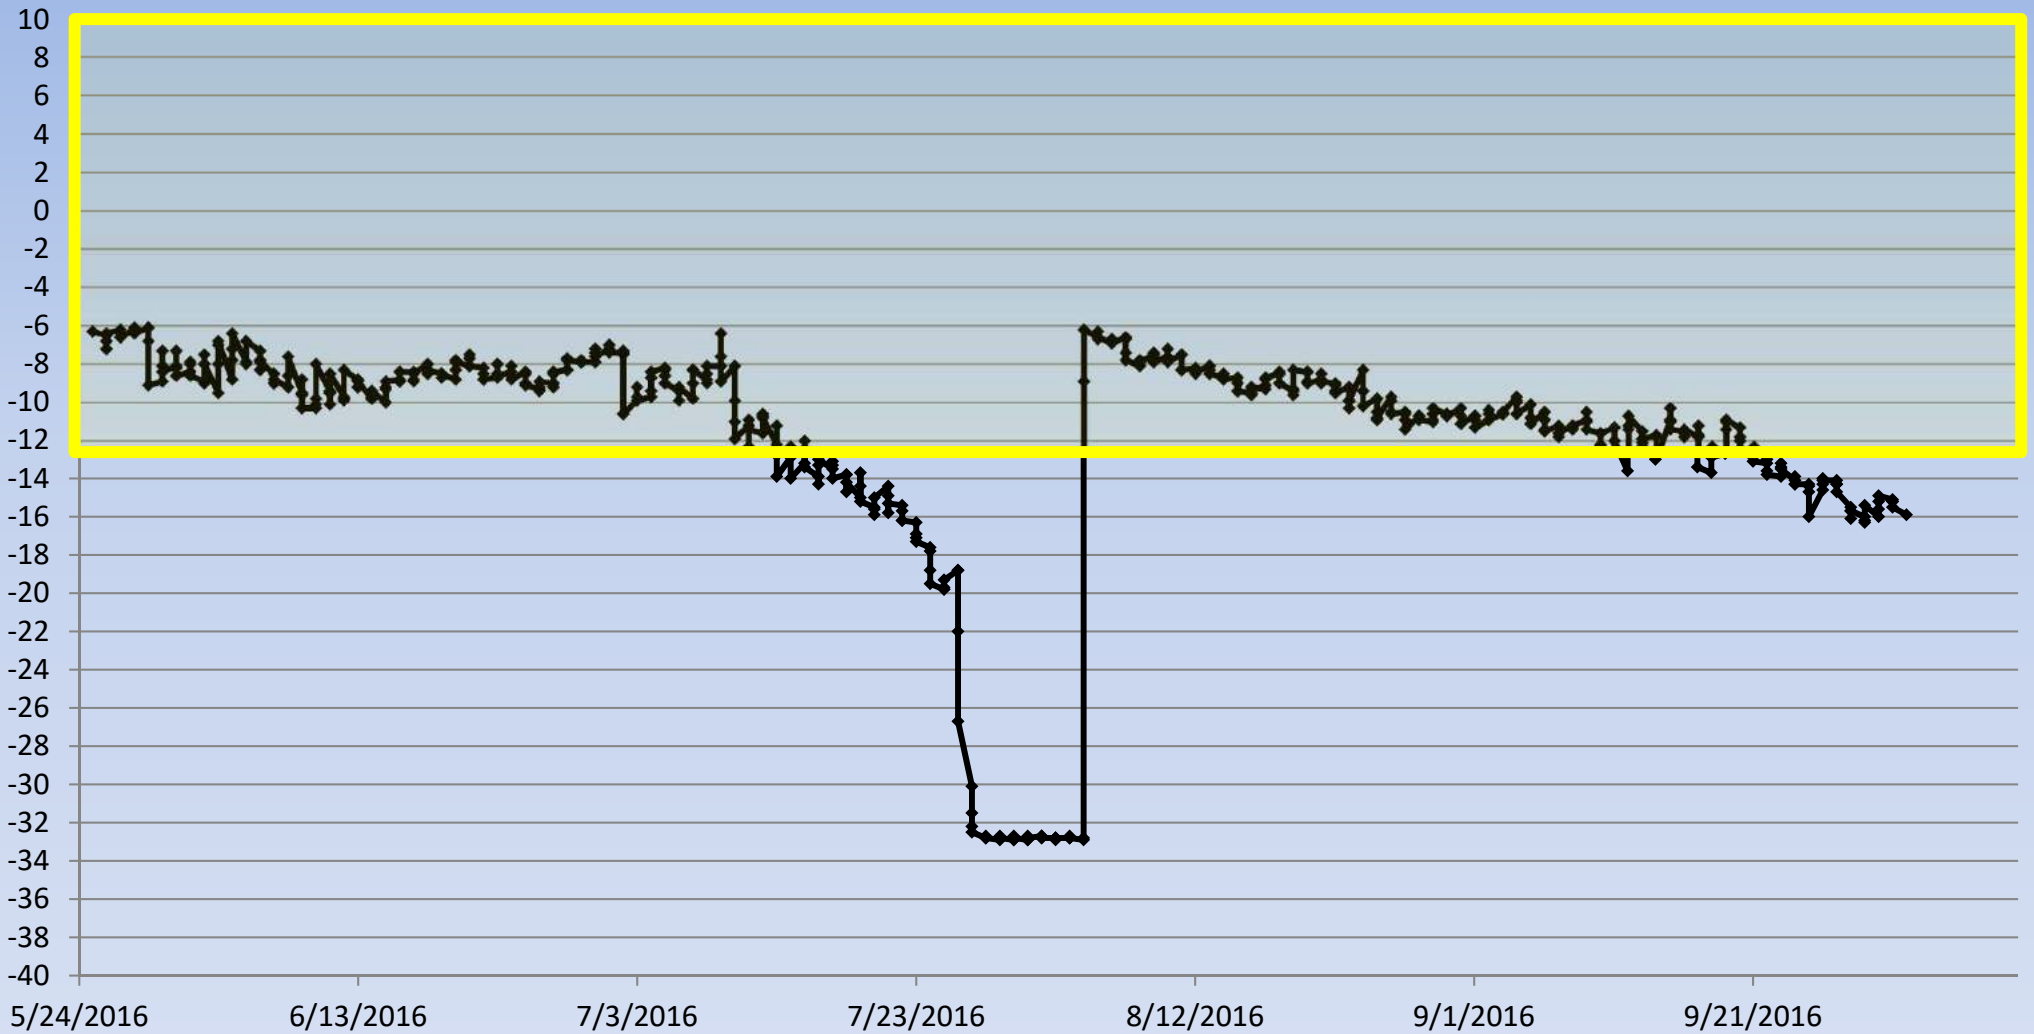
# CGP-A 2016 Hydrograph

Status of Well A for 2012 -2016. THD is total hydraulic days, and CHD is consecutive hydraulic days when the static water table less than 12 inches deep. A minimum of 14 CHD is required to classify as wetland hydrology.

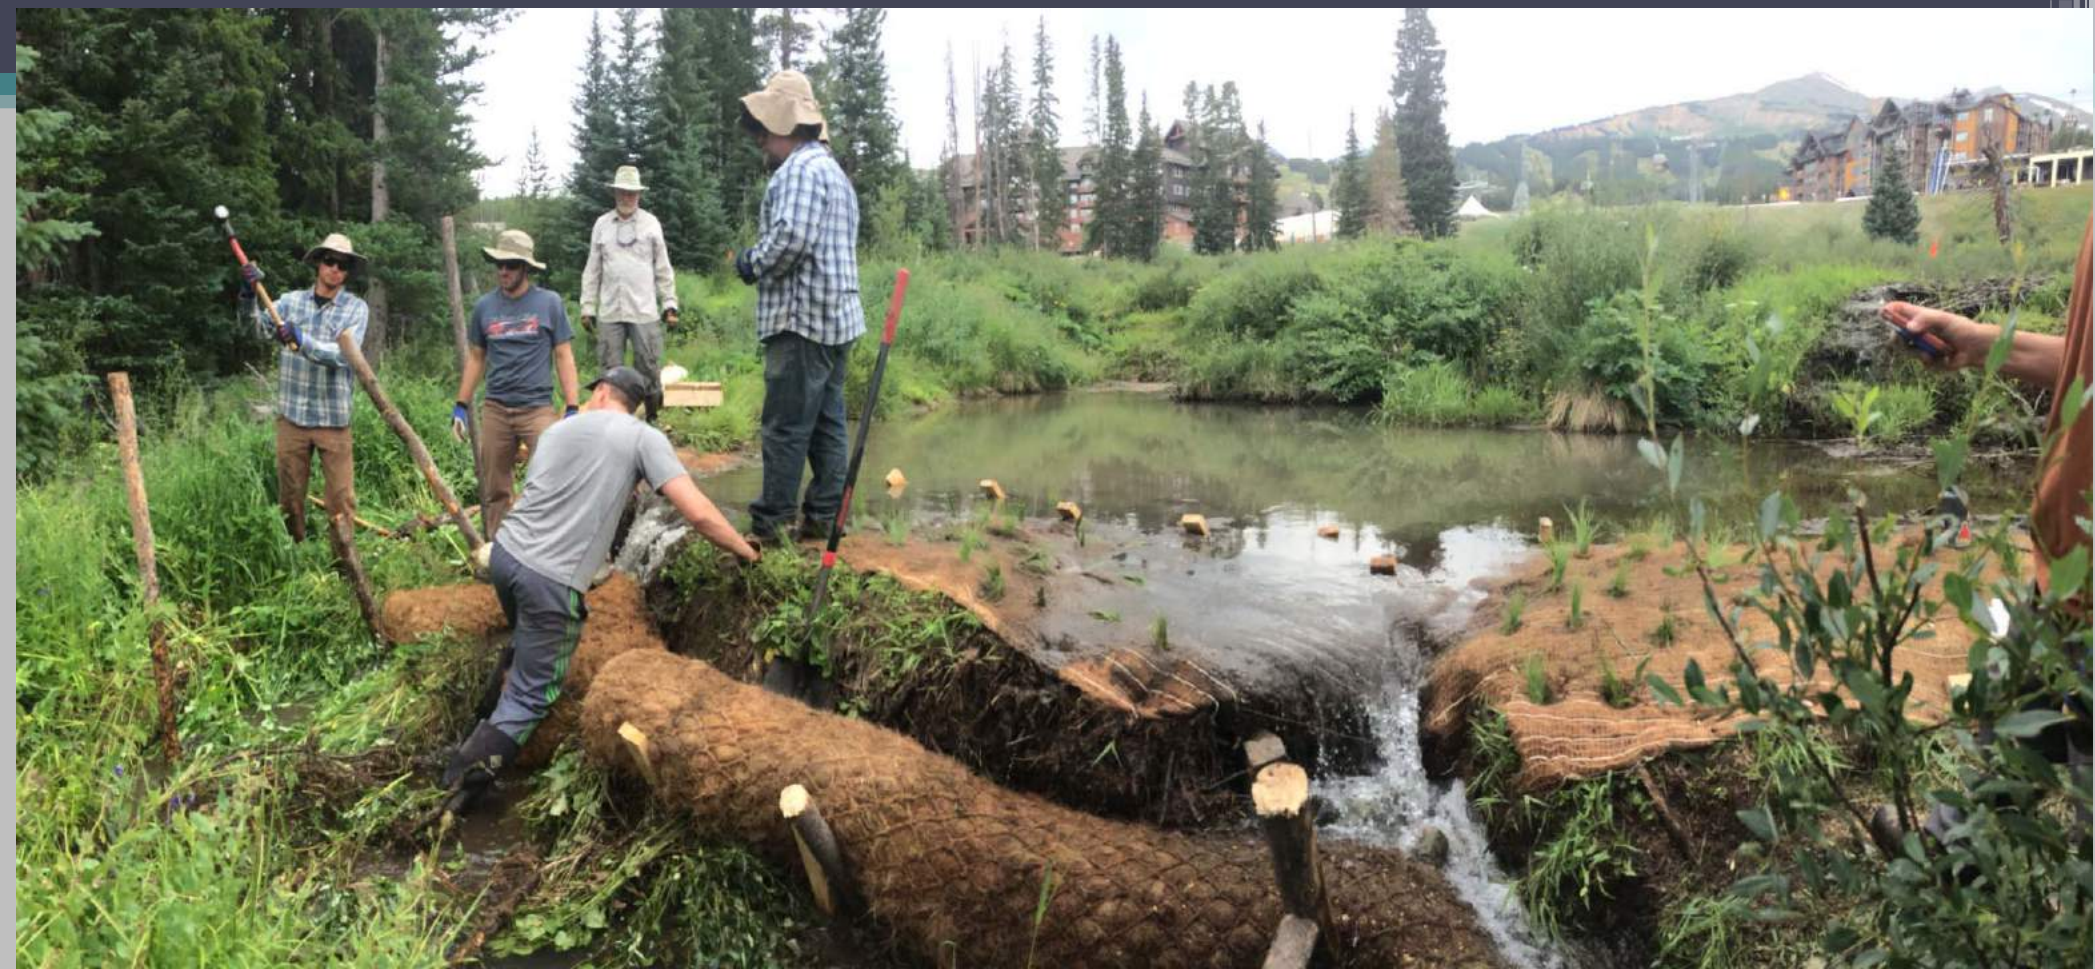
Coir logs were used on the downstream side of dams to increase dam strength and to create roughness at the outflow locations. The coir logs are held in place with wooden spikes. The picture on the lower left is of the main dam breach. The upper and right photos show preventive measures taken on ponds below the spreader.
