# There goes the neighborhood! Water quality challenges in a changing environment

Jessica Doran, EcoMetrics  
Anne Murphy, Town of Breckenridge

# Cucumber Gulch Preserve

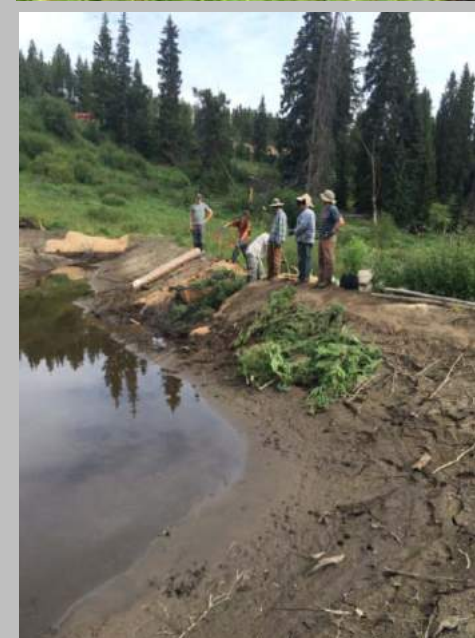
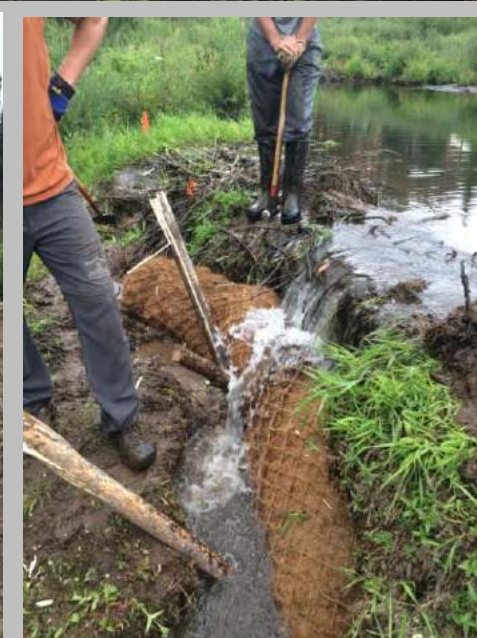
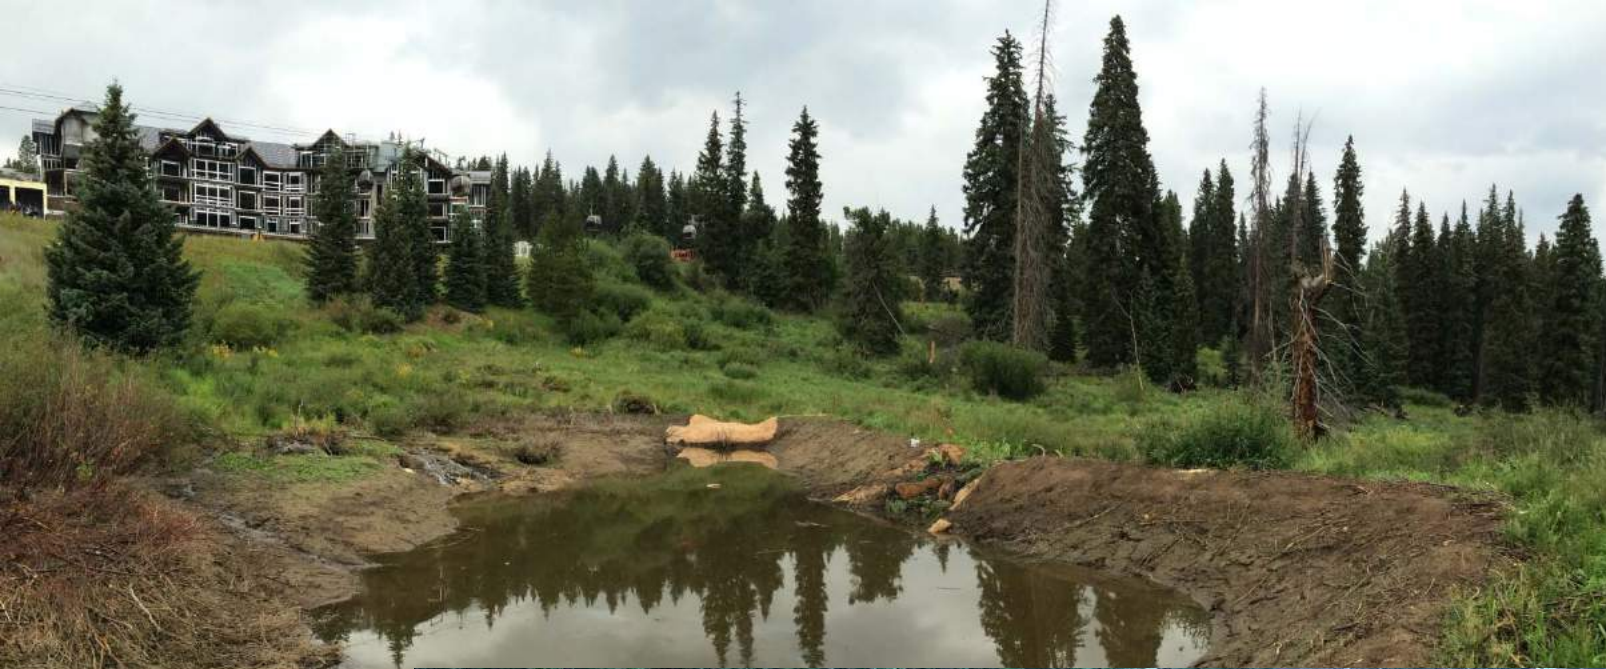
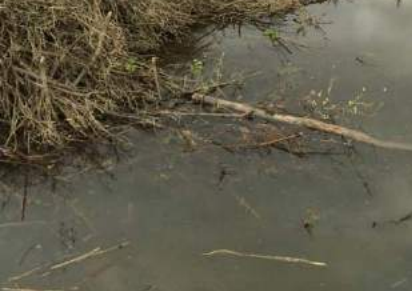
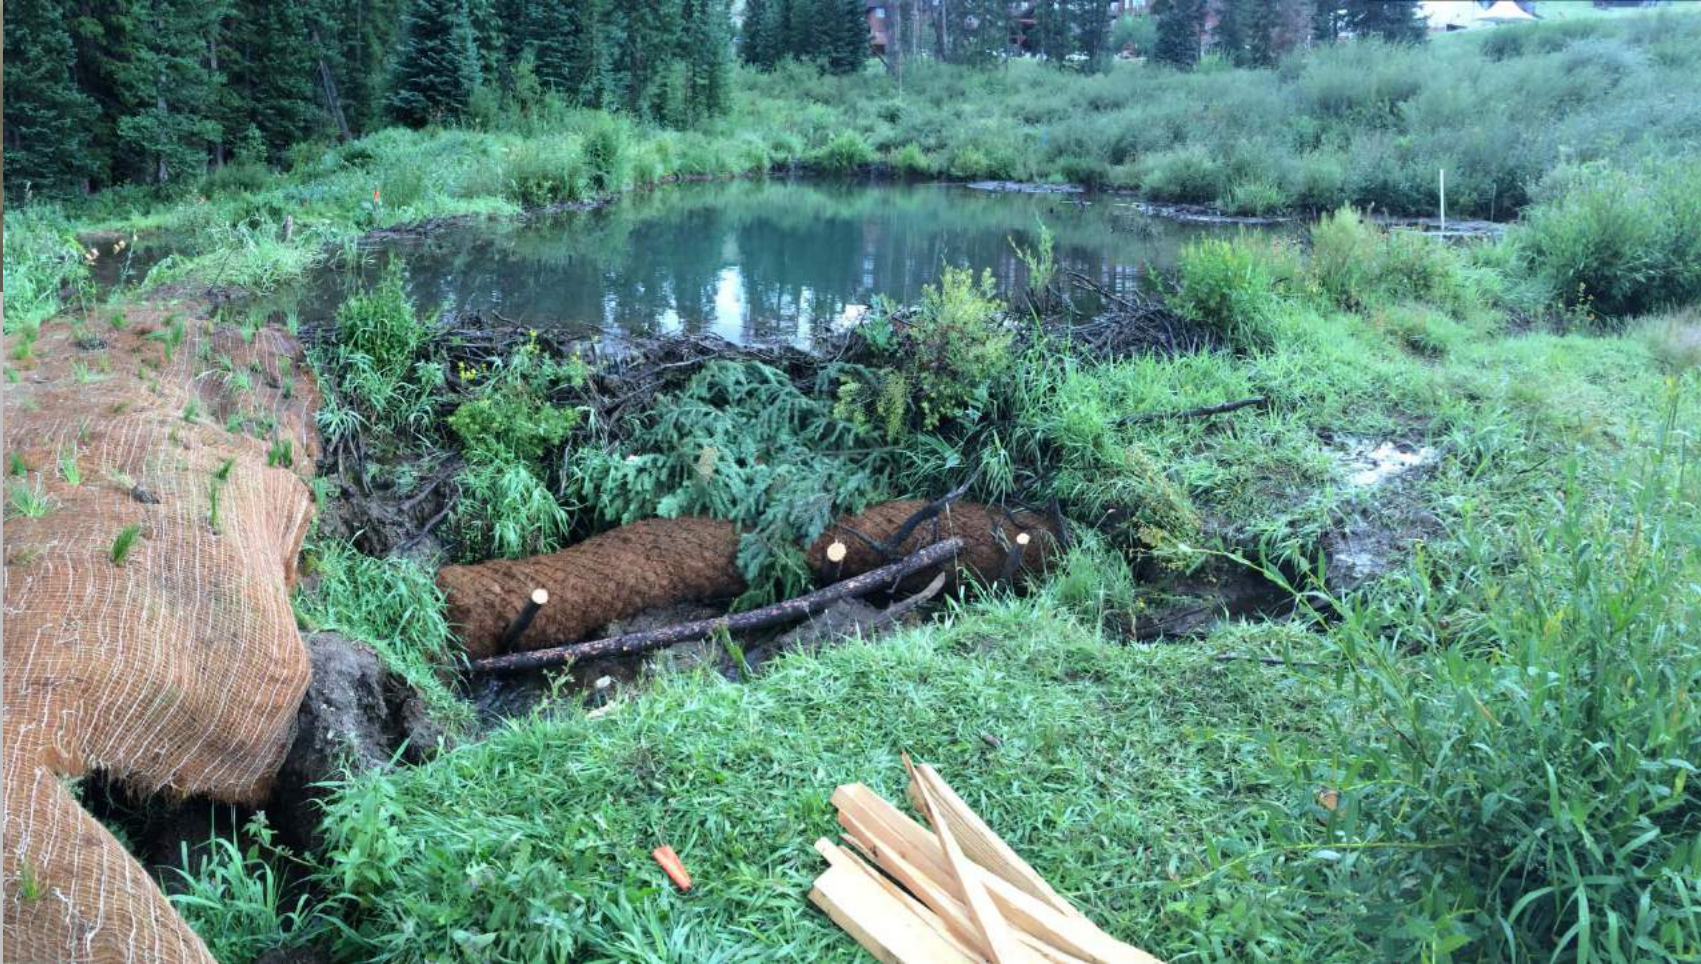
Coir logs were used on the downstream side of dams to increase dam strength and to create roughness at the outflow locations. The coir logs are held in place with wooden spikes. The picture on the lower left is of the main dam breach. The upper and right photos show preventive measures taken on ponds below the spreader.

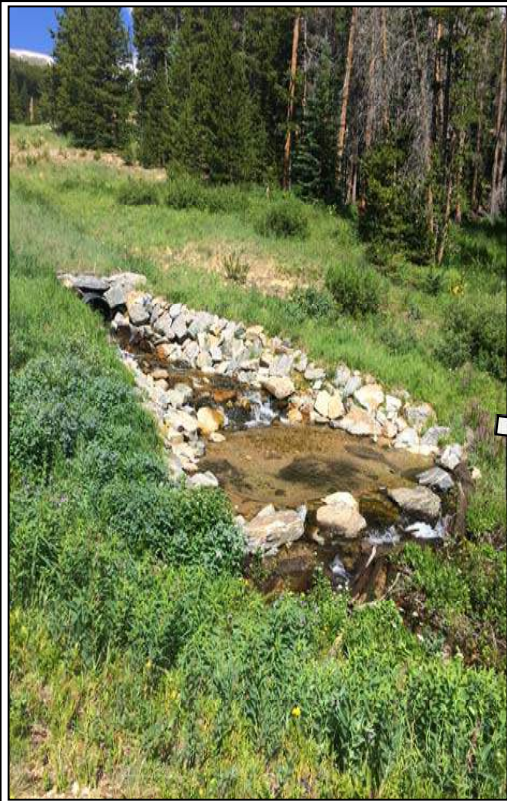
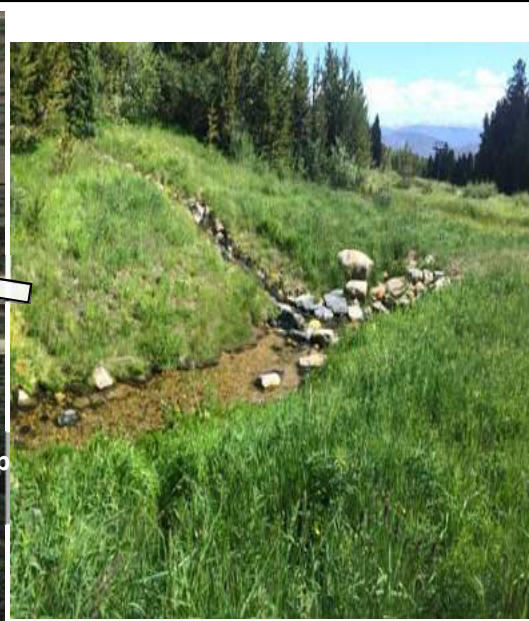
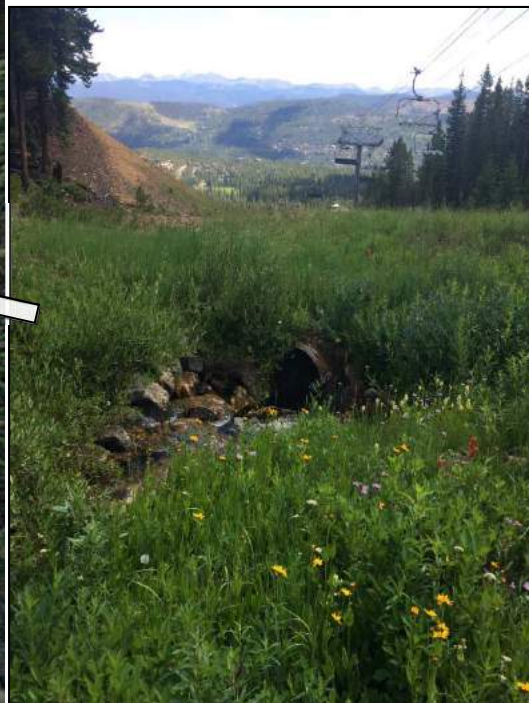
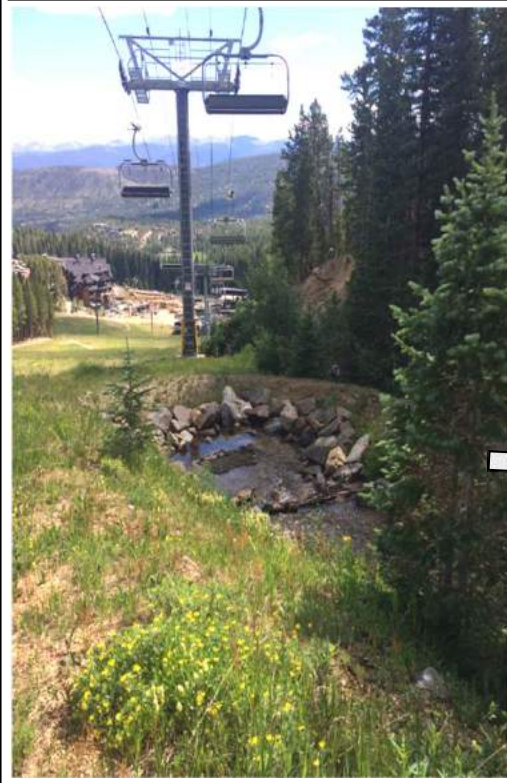
Structures and sediment trap priorities on Boreas Creek and pipeline

DRAWING: Structures and sediment trap priorities
PROJECT: Opportunities to trap sediment on Boreas Creek above CGP
LOCATION: Breckenridge Ski Area, Peak 8
DATE: September 8, 2017
SHEET: 2 of 3

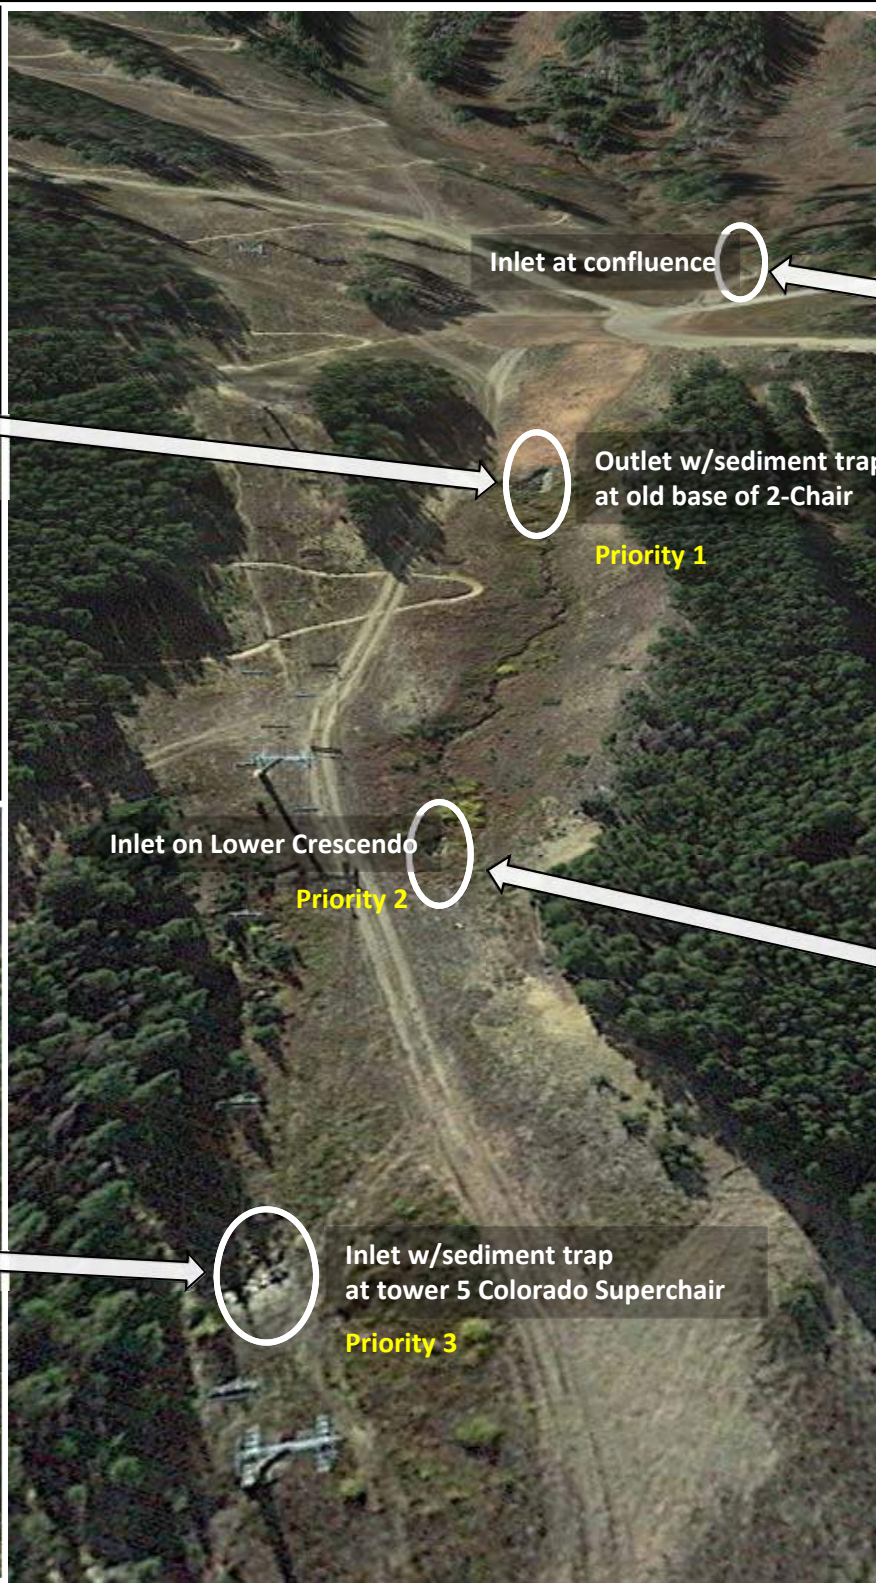
## 1. Outlet at old base of 2-Chair

The existing trap has a storage capacity of about 1-2 CY of sediment and is currently full. If this basin was enlarged for an effective storage capacity of 10 CY, it could function as a sediment trap for most of a normal season as long as it was cleaned out annually. There is room to construct a larger basin at this site by making the existing basin longer, wider, and deeper. The site has good access for construction and cleaning from the service road and no major permitting issues.

## 2. Inlet at Lower Crescendo

There is currently no sediment trap or storage capacity at this site, but there is room to construct a 10-CY basin to capture sediment that passes through the traps upstream plus any additional sediment entering below them. The site has good access for construction and cleaning from the service road and no major permitting issues.

## 3. Inlet at tower 5 Colorado Superchair

The existing trap has a storage capacity of less than 1 CY of sediment and is currently full. Storage capacity is too low for it to function as an effective sediment trap. A 10-CY basin could be constructed at this site by making the existing basin longer and deeper. Without interfering with the ski run. There is good access for construction and cleaning and no major permitting issues.

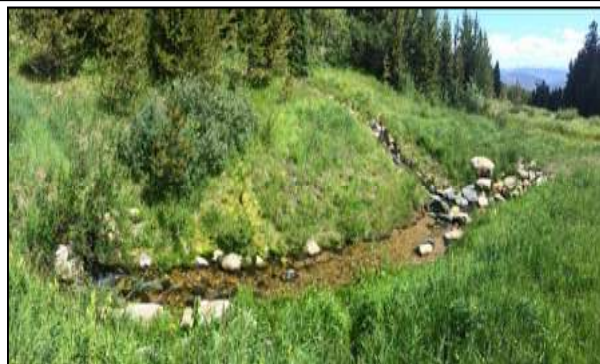
## Additional opportunities

Additional opportunities for capturing sediment on Boreas Creek may exist, especially at structures upstream of the old base of 2-Chair. These sites are lower priority due to more difficult access and potential wetland permitting issues.
